Crack path and fracture analysis in FSW of small diameter 6082 aluminium tubes under tension-torsion loading

Abstract

This paper reports part of the work done in a research project aimed at developing an optimised process to join 38 mm diameter tubes of 6082-T6 aluminium alloy using friction stir welding (FSW), and then to determine the fatigue performance under tension, torsion and tension-torsion loading conditions. The final outcome of the project is intended to be guidance for fatigue design of small diameter aluminium tubes joined by FSW, and this paper presents information on crack path and defects under the various loading conditions. Crack path analysis was performed using both low magnification stereo microscopy and scanning electron microscopy, in order to identify crack initiation sites, the direction of crack propagation and the interrelated influence of microstructure and weld geometry on the crack initiation path.

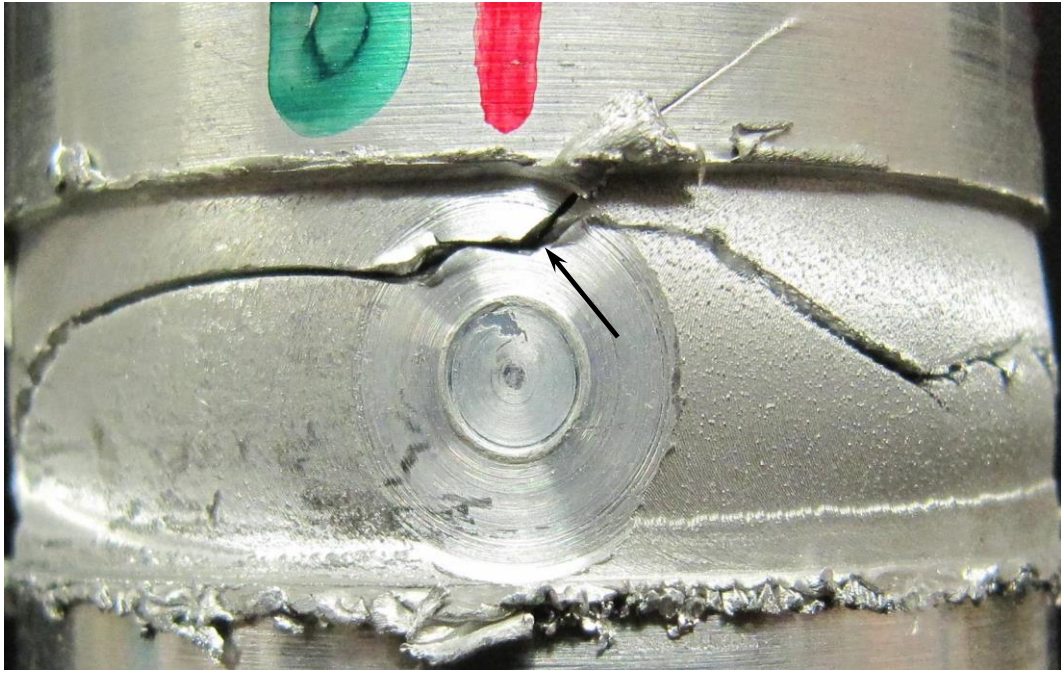
Figure 8a Crack initiation site (marked with arrow) in specimen T4 tested in torsion at $R = -1$ with a shear stress amplitude of 75 MPa.

Table 6 presents the data for the torsional specimens, and it should be noted that the torsional loading damages the fracture surfaces and usually makes impossible post-hoc determination of the crack initiation point around the circumference. The torsional data indicates a significant influence of both stress ratio R and shear stress amplitude on the position and crack path associated with crack initiation. Thus under torsional fatigue loading with $R = 0$, crack initiation occurred on the retreating side in all welds examined, whilst under reversed loading with $R = -1$ crack initiation predominantly occurs on the advancing side. Under torsional loading, at the two lowest shear stress ranges used in both $R = 0$ and $R = -1$ loading, the crack path does not follow the undercut zone at the sides of the weld, but instead shows a more classical shear crack initiation at an angle of approximately 45° (see the two images given in Figure 8).

Certain of the in-phase tension-torsion specimens, e.g. IPh8 and the torsion specimens, e.g. T4 exhibited crack initiation coincident with the stop-start position, as shown in Figures 12 and 8a, respectively. Torsion fatigue specimens occasionally showed classic shear crack bifurcation under torsion loading with $R = -1$ and Figure 13 shows an example of this type of cracking where crack initiation has also occurred at the stop-start position. Table 8 summarises the crack location information for all specimens and shows that for the 62 specimens where this information was obtained, 50% of cracks initiated at the advancing side, 39% at the retreating side and 11% at other positions in the weld.

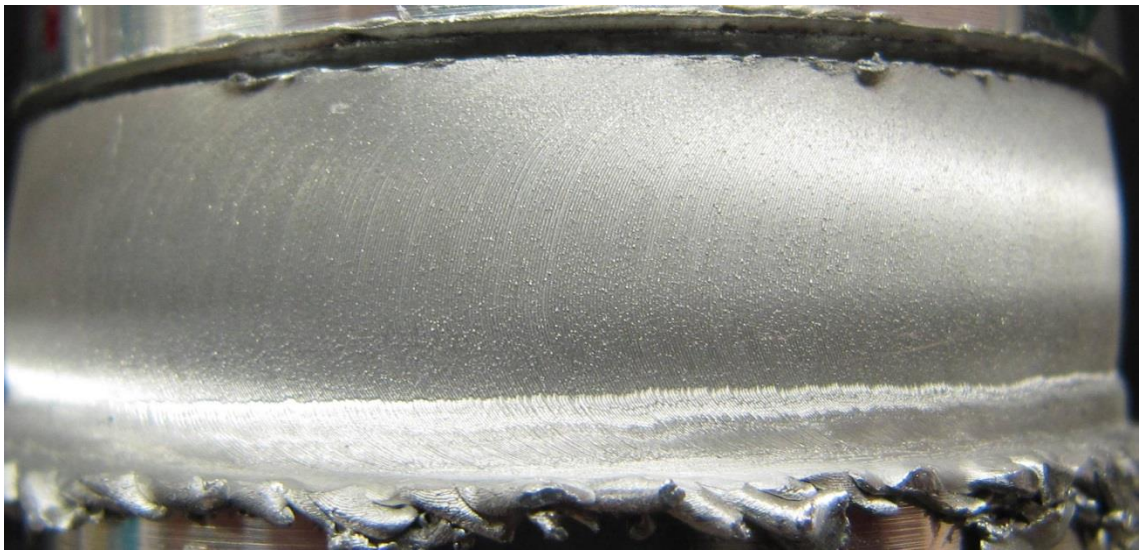
Figure 8b Crack initiation site in specimen T22 tested in torsion at $R = -1$ with a shear stress amplitude of 133 MPa. The crack runs around the undercut groove on the advancing side of the weld. This is the most common mode of failure in both tension and torsion fatigue specimens.

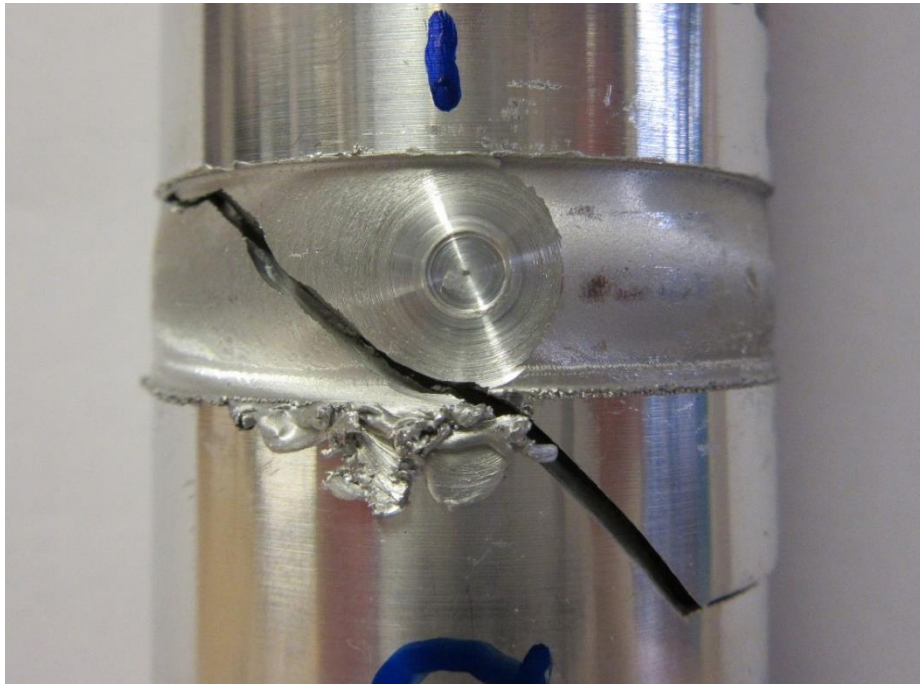
Figure 12 Certain tension-torsion specimens showed crack initiation associated with the stop-start position. This is specimen IPh8.

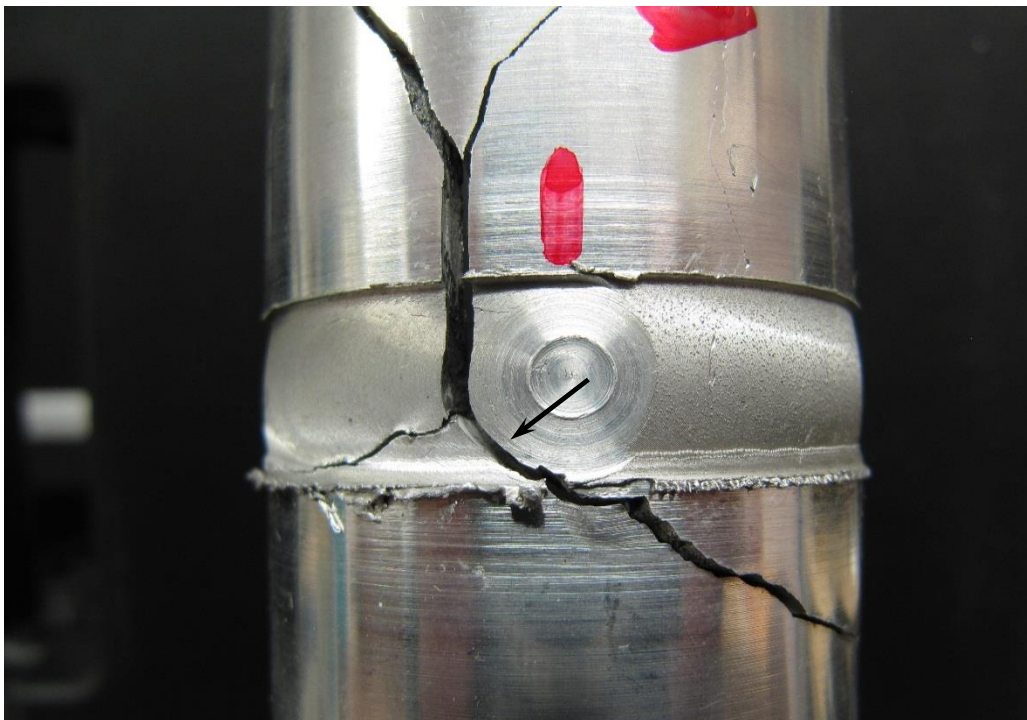
Figure 13 Specimen T6 which showed classic shear crack bifurcation. The arrow marks the crack initiation site which is also associated with the stop-start position.

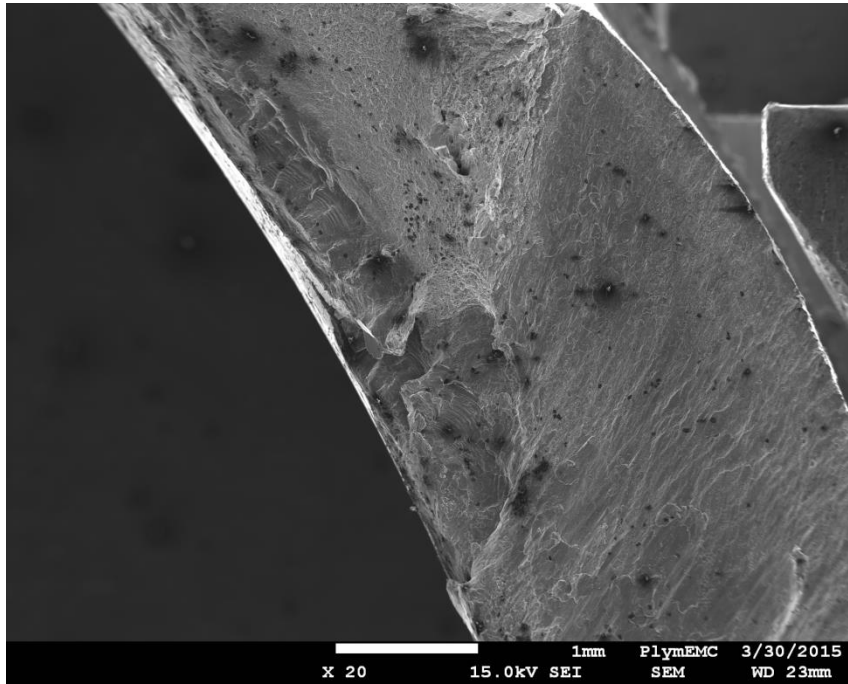
Figure 16 Clear evidence of initiation of the primary fatigue crack from the outer edge of specimen IPh2 can be seen at the upper right hand corner in this image.

specimens indicated that although the primary crack had initiated at the outside of the tube (in-phase tension-torsion specimen IPh2 - Figure 16), smaller secondary cracks had sometimes formed at the inner surface later in the fatigue process (IPh2 - Figure 17). Figure 17 also demonstrates that the formation of this secondary crack occurred at a late stage in the fatigue process because the fracture surface fairly quickly starts to reflect the underlying 'onionskin' structure in the weld zone, reflecting high levels of applied load and hence high growth rates. Where fracture surfaces were undamaged, the mechanism of fatigue crack growth could be observed to be ductile striation formation as shown in Figure 18 (tension fatigue specimen W130).

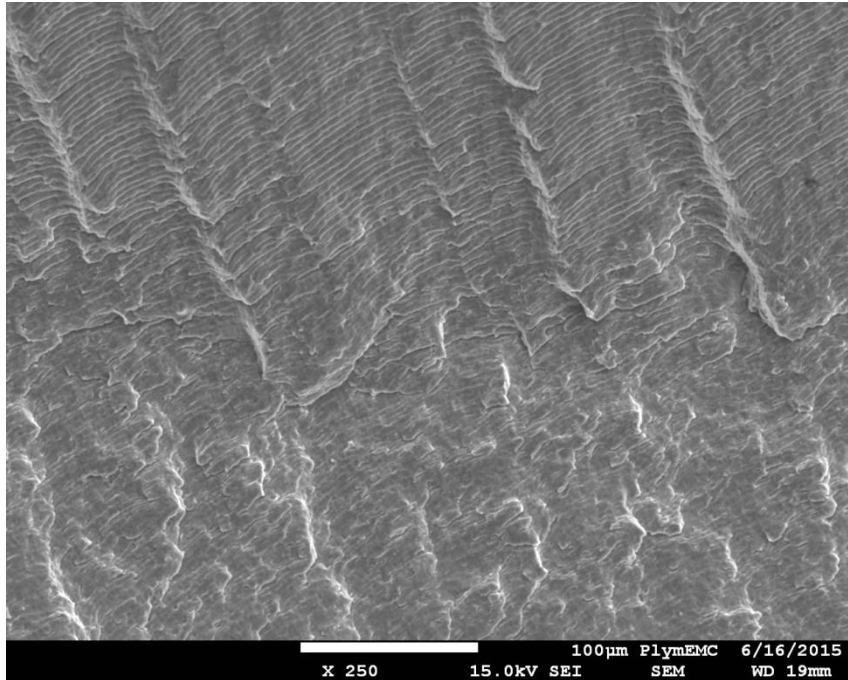
Figure 18 The mechanism of fatigue crack growth was by ductile striation formation; this image shows the fracture surface on tensile fatigue specimen W130 and the crack growth direction is from the bottom of the image to the top.

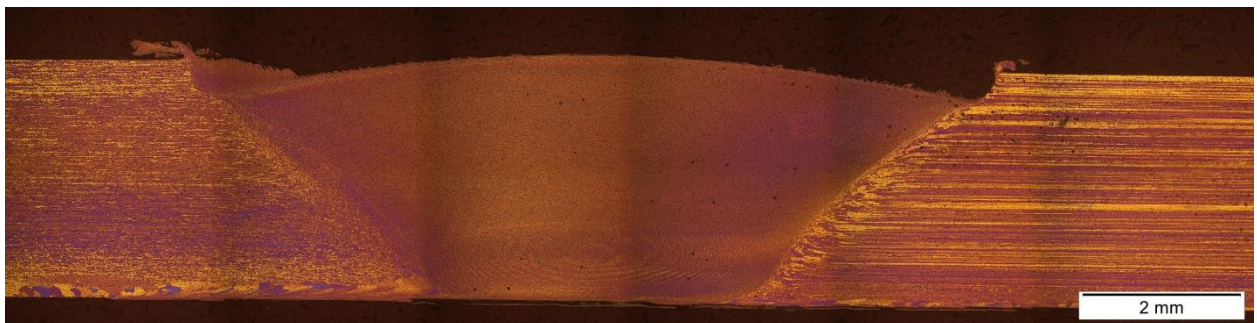
Figure 19 Polarised light metallographic montage showing the complete weld zone in specimen T6 tested in torsional fatigue.

Ultimately, it is intended to evaluate the microstructure and crack path using polarised light microscopy and electron back-scatter diffraction (EBSD) in a scanning electron microscope, but this work has not yet been completed. Figure 19 shows a polarised light metallographic montage that shows the complete weld zone for the torsion specimen T6. Individual regions of the microstructure can be examined at higher magnification (Figure 21). This can also be done for cracked specimens, although it entails polishing back the surface to provide a flat region for etching, and the etching process trends to attack crack edges preferentially. This is where EBSD has a distinct advantage over light microscopy, although it also requires a flat surface in order to adequately index the microstructure and the plastic deformation that surrounds cracks can therefore lead to a loss of resolution. Figure 21 shows a typical EBSD image of the crack tip region in specimen T6 at 2,000x magnification and a fairly good resolution of the microstructure has been obtained to within a distance of about 10 μm from the crack edge. The interesting point that this image does not make clear is whether grain refinement has occurred due to plastic strain in the zone near to the crack tip, or whether this apparent effect merely reflects a loss of data in this heavily deformed region. The EBSD image shown in Figure 22 contains the crack initiation region in specimen IPh-1, looking at the crack growing down through the tube thickness. The crack has initiated and grown along the tool shoulder undercut on the advancing side of the weld

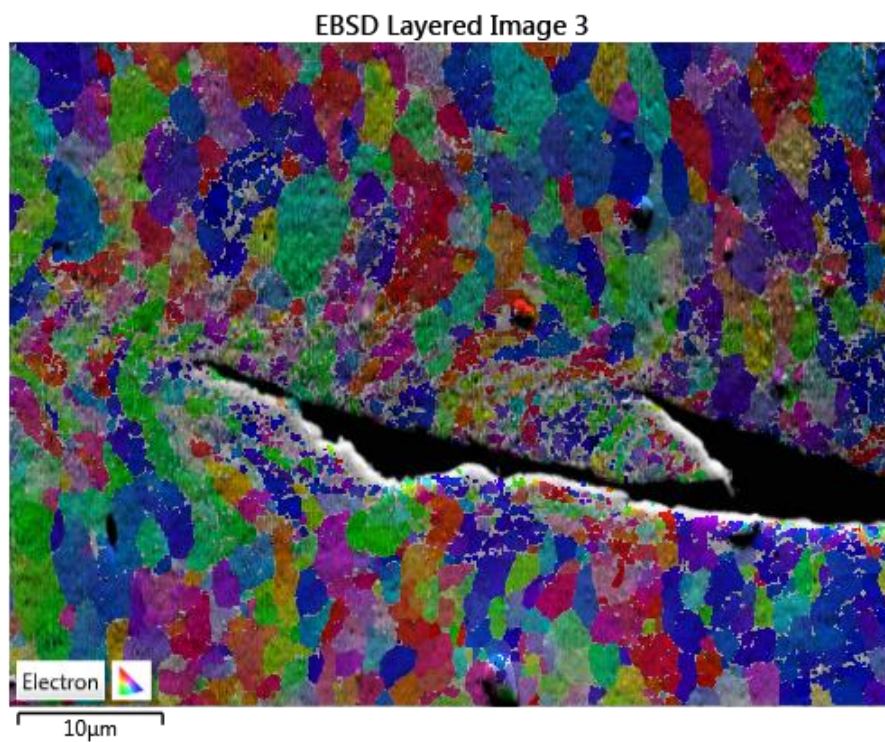
Figure 21 EBSD image showing the crack tip region in specimen T6 at 2,000x magnification.
